NOTICE TO MARINERS

No 07 (T) of 2022

Port of Southampton – Pilot Boarding and Disembarking Vessels – Non-compliant and Defective Pilot Ladders

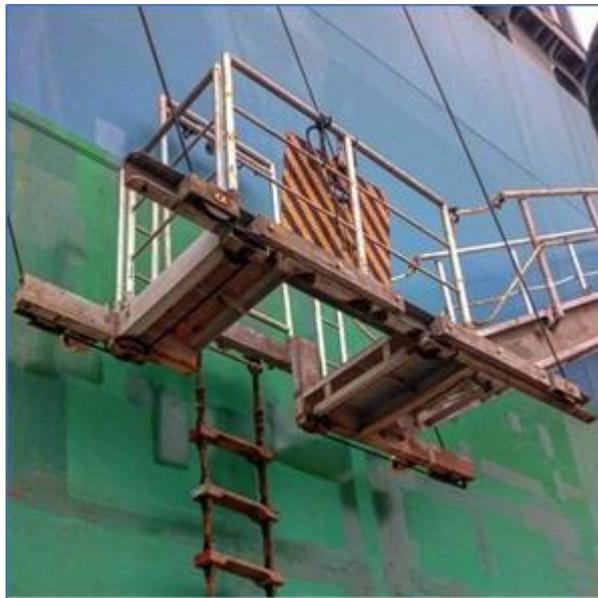
Fig 1: Non-compliant Arrangement

The arrangement at figure 1 is non-compliant because:

- The pilot ladder is not rigged to extend through the trapdoor and secured 1½ metres above the bottom platform (SOLAS 3.3.2.1). The method of securing the ladder to the underside of the platform shown in the figure is dangerous because the transition from the pilot ladder is done via an uneven step height.
- The horizontal cross member to which the pilot ladder is secured is a distraction from using the side ropes when transitioning onto the pilot ladder when disembarking.

- The pilot ladder steps cannot rest firmly against the ship's side, due to the nylon wheels attached on the inboard side of the bottom platform.
- The 'sloping ladder' is not securely attached to the hull.
