FLYER TO THE LEISURE INDUSTRY

ORCA: accident leading to a fatality on 8 June 2014

Marine Accident Investigation Branch
May 2015

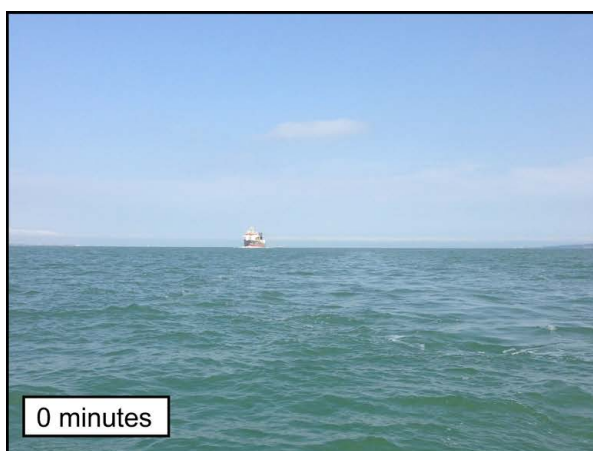
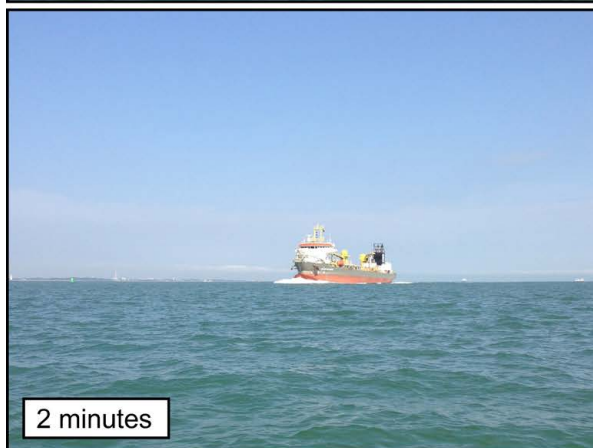
The following four pictures, taken from a stationary vessel, give an indication of how rapidly a vessel, in this case a dredger, can approach.

- Leisure sailors need to be particularly aware of closing speeds between their own vessels and other vessels. In this case, *Shoreway* was travelling at 12.9kts but many types of vessels, including ferries, cruise ships and container ships, regularly sail at speeds over 25kts and, as a result, distances that initially appear sufficient can be reduced surprisingly quickly.
