NOTICE TO MARINERS

No 05 (T) of 2023

Port of Southampton – Pilot Boarding and Disembarking Vessels – Non-compliant and Defective Pilot Ladders

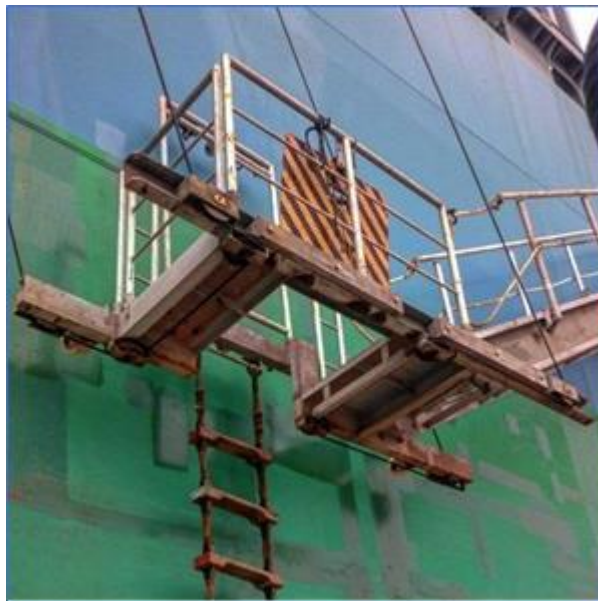
Fig 1: Non-compliant Arrangement

The arrangement at figure 1 is non-compliant because:

- The pilot ladder is not rigged to extend through the trapdoor and secured 1½ metres above the bottom platform (SOLAS 3.3.2.1). The method of securing the ladder to the underside of the platform shown in the figure is dangerous because the transition from the pilot ladder is done via an uneven step height.
- The horizontal cross member to which the pilot ladder is secured is a distraction from using the side ropes when transitioning onto the pilot ladder when disembarking.

- The pilot ladder steps cannot rest firmly against the ship's side, due to the nylon wheels attached on the inboard side of the bottom platform.
- The 'sloping ladder' is not securely attached to the hull.
